PRACTICAL EXPERIENCE WITH ASPHALT REINFORCING POLYMER GRID AND COMPOSITE IN AIRFIELDS

Fabiana LEITE-GEMBUS ^a, Zehra KAYA ^b and Graham THOMSON ^c

^a Huesker Synthetic GmbH, Germany

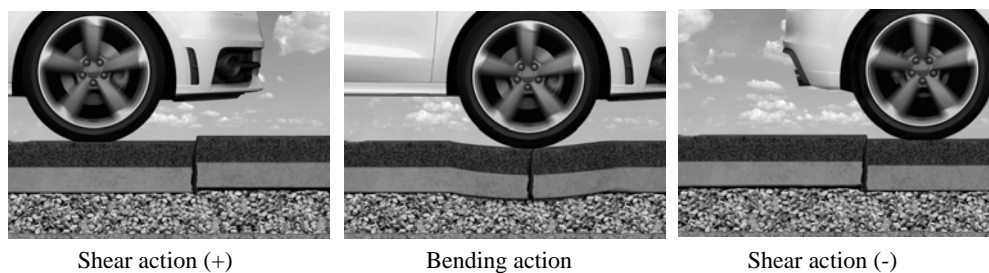
Figure 1. Critical loading cases in a pavement crack

When a wheel load passes over the road construction, localized bending and shear stresses appear on the existing crack and cause the origin and further development of cracks (Montestruque, 2002; Norambuena-Contreras and Gonzalez-Torre, 2015). The shear action occurs twice by each load application, while the bending action occurs only once (Figure 1).

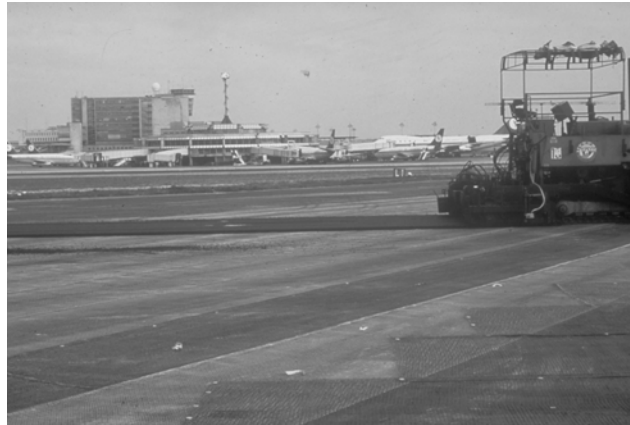
Figure 4. Installation of the polyester reinforcement at Brussel Airport in 1979

Firstly 10 mm existing asphalt were milled off the runway surface, then any holes broken out of the concrete slabs were in-filled and a bituminous regulating course was applied. Then, an asphalt reinforcement made of high modulus polyester was installed on top of the regulating material (Figure 4).

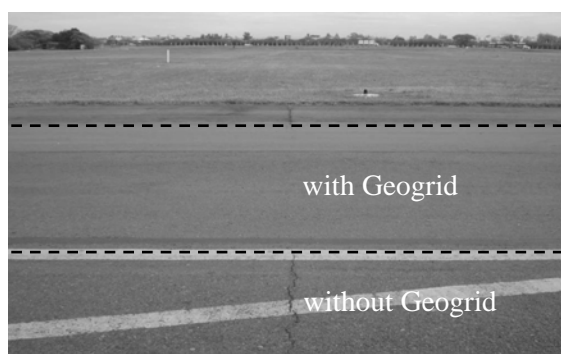
Figure 6. Joints of the concrete slabs reflect in the area where no reinforcement was used

In October 2007, approximately 7 years after the rehabilitation, the first assessment of the pavement took place. At that time the designer, the technical manager of the airport, and an employee of the reinforcement manufacturer were present. The expansion joints in the concrete beneath the unreinforced pavement areas had already propagated to the top of the surfacing. The vegetation, visible in the developed cracks, led to the conclusion that these cracks had existed for some time. In contrast, the PET-grid reinforced areas did not show any indications of cracking (Figures 5 and 6).

Because the unreinforced section was not subjected to aircraft traffic, the propagation of the expansion joints in these areas can be conclusively attributed to the horizontal stresses that resulted from changes in temperature. The areas reinforced with the polyester grid were subjected to both temperature-induced and aircraft traffic-induced stresses. For further details the reader is referred to a paper prepared by Monser et al (2010).

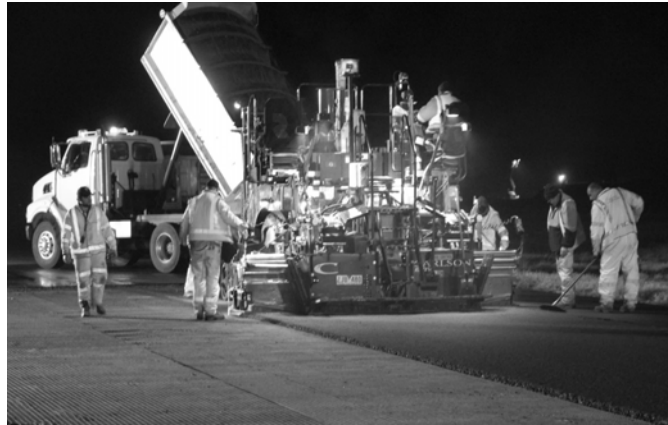
Figure 7. Laying asphalt over polyester asphalt reinforcement

Additionally, in order to mitigate the propagation of the existing concrete pavement failures into the new asphalt surface, an asphalt reinforcement made from high modulus polyester was installed between the two 50mm AC layers as seen in Figure 7. Works were completed at night between 10 p.m. and 6 a.m. The treatment area was 100 m in length across the full taxiway width.
